October 12, 2016

Project: Pre-construction assessment for property re-development at 15511 NE 90th Street, Redmond, WA. Parcel number 022505-9224.

Objectives: Evaluate health of existing trees and establish criteria for the preservation of those to be retained.

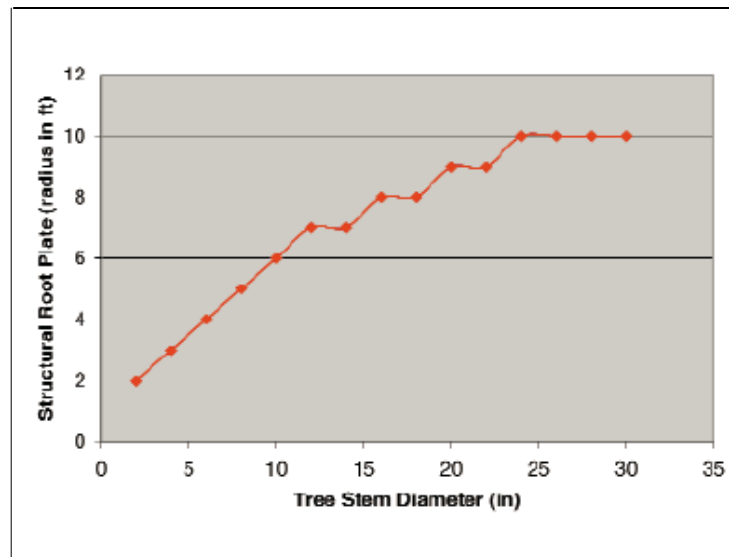
Figure 29. Size of the Structural Root Plate in relation to tree stem diameter. Note that the SRP levels off at 10' for any tree over 24" in diameter.

Trenching type incursion, that is excavation that will occur along only one sector of a tree's CRZ, can reach significantly into the root growth area without having a detrimental long term effect. What does have to be absolutely protected is a tree's Structural Root Plate (SRP). This radial area is again related to the diameter inches of the tree in question but not quite in a direct proportion as in the CRZ. Figure 29 below illustrates the relationship.

In the case of the #10 fir mentioned above, the demolition of the old building will come as near as 10' to the base of the tree. From Figure 29 the Structural Root Plate for a 15" DSH tree is given as 7' so the excavator should not interfere with its SRP. The #12 fir also has a 7' SRP and should be OK.

The #42 fir is a more difficult case as the demolition will come to within 6' of the base of the tree but only at an acute angle. The limit of incursion is the same as for the #10 tree, 7' so the onsite arborist will have to make sure that there is no occurrence of root damage inside that limit.

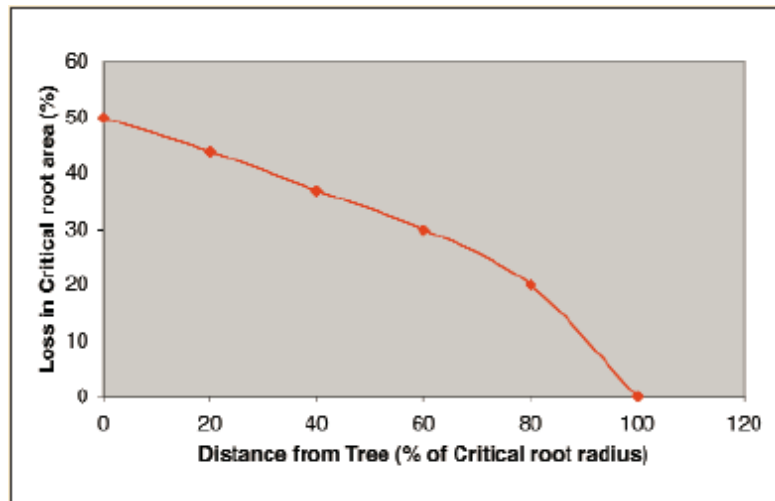
Figure 30. Chart giving the loss in critical root area as a function of the radial distance to the CRZ disturbance.

The chart shown in Figure 30 below is used to determine what percentage of a tree's Critical Root Zone will be affected by trenching type incursion. In general trees can sustain losses of up to 30% of the overall area within their CRZ without having long term detrimental results.

Using the #10 fir again as the example, with the demolition excavation being 10' from the tree's base and it having a 15" DSH, there will be impact at a linear distance equal to 66% of the fir's CRZ. The chart shows that this equates to about 27% loss in Critical Root Area (CRA) and the fir should be fine long term. The CRA loss for the #12 fir (10'/14" DSH) would be roughly 25% and it would be expected to survive the impact with no long term detrimental effects.

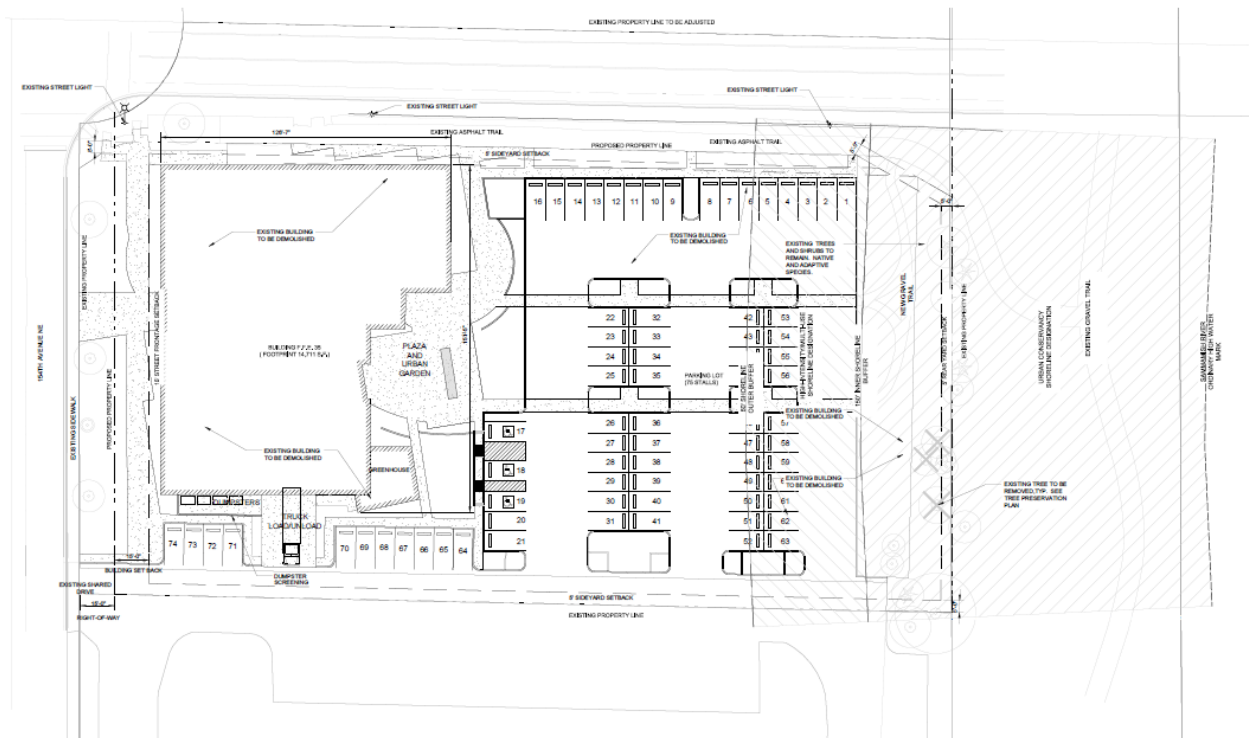
Figure 2. Concept of site redevelopment. Compare to existing above.

The existing buildings will be razed and the proposed changes for the property include a main parking area covering the east half of the site and a smaller main building on the west side as shown in Figure 2. The landscape islands within the parking areas will be reworked also.

On the west side the #1-#4 oaks are within the primary impact region shown in Figure 2 which will be reformatted for the new building entrance. Ultimately the new hardscaping will create more root space for these four trees. They should be able to be retained as long as the demolition work is done carefully. A great deal of the asphalt and curbing removal will have to be done by hand. It will be beneficial for these trees to have deep root feeds post construction to both break up the existing compaction and to aid in impact stress recovery.
